1. INTRODUCTION

Wilfred Baker Engineering, Inc. (WBE) was contracted by Film Technologies International, Inc. (FTI) to test the performance of their batted safety film under blast load conditions. Tests were performed on two variations of batten systems provided by CHB Industries and Window Lock™. All specimens were tested on October 15 and 16, 1998 at WBE's shock tube facility located in Elmdorf, Texas. WBE utilized an 8 ft x 8 ft shock tube to produce blast loads for all tests.

The objective of the test program was to determine the performance of the batted safety film when subjected to the design blast loads for Level C and Level D Waterways Experiment Station (WES) Test Series.

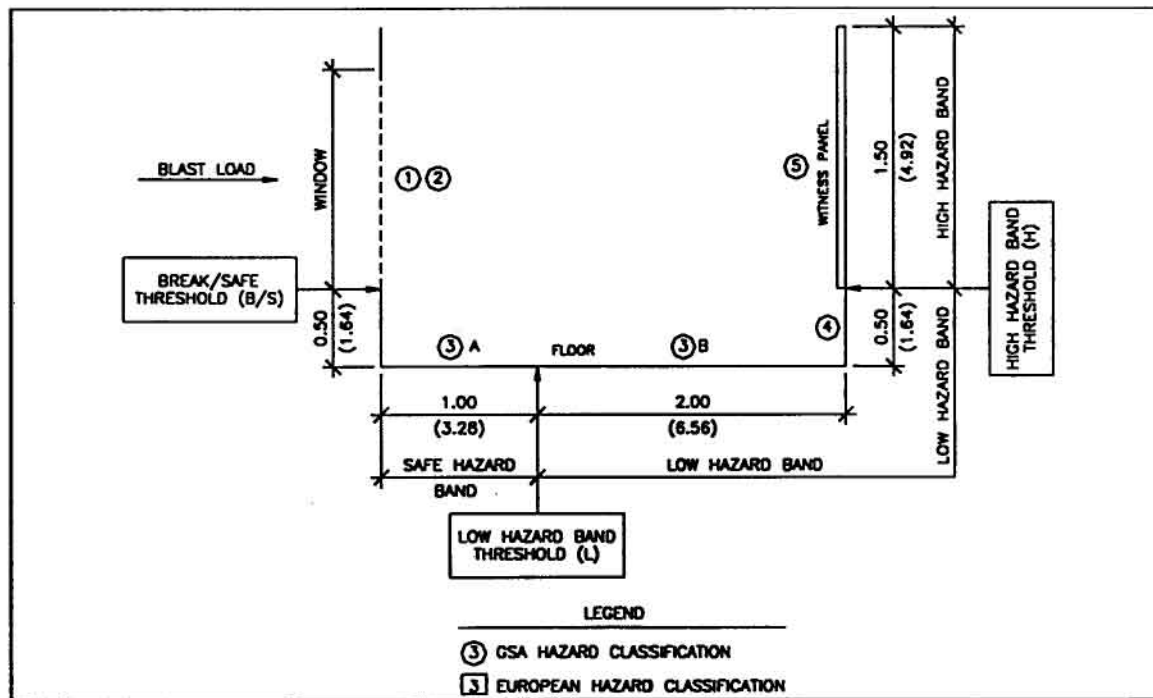
Figure 1.1 Classification Sketch

Performance was evaluated by comparing residual glass fragment hazards with criteria developed by the Security Facilities Executive (SFE) in the United Kingdom and incorporated into GSA's glazing performance criteria. The criteria defines three hazard levels corresponding to Break Safe (1 and 2), Low Hazard (3a, 3b, and 4), and High Hazard (5) levels. See Figure 1.1 for classification sketch.
